Each month Dr Jeep (Tony Whitehead) takes us through the trials and tribulations at his "Jeep Hospital", USA 4X4 Jeep Specialist in Melbourne, Victoria. Over 20 Jeeps are admitted weekly for servicing and suspension work through to differential, transmission and engine rebuilds. Dr Jeep explains the diagnosis, the corrective surgery and future care of these vehicles.

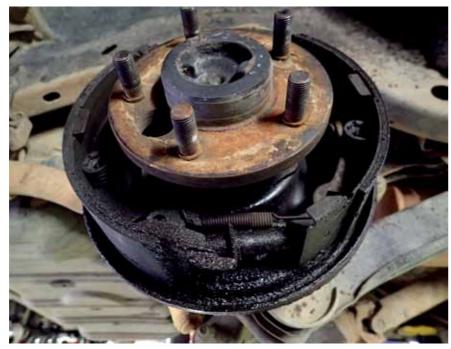
DANA 44 TJ AXLE SEAL

The rear axle seals on a TJ have a tendency to weep. A worn seal lets diff oil out and water in, a bad combo for the internals of the diff or the brakes. These brake shoes are not worn out, but are so badly contaminated there is no option but to replace them and a new seal. The design of these rear axles means you need to destroy the wheel bearing to change that seal. When doing so, also check that the seal surface has not been grooved too badly. If so, the axle will need replacing as well. A lot of trouble over a \$20 part. We always check the wheel cylinders too while we're in that far, they can leak brake fluid and/or rust solid and offer poor rear brake performance.

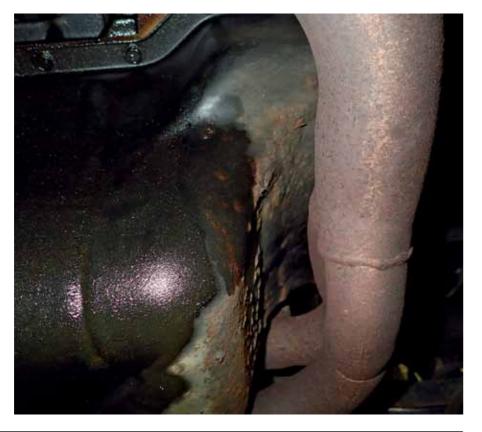
RUSTY SUMP

This is a first for me, this 4.0L sump was so badly rusted it's going to need replacing. Too bad the rocker cover oil leak hasn't been able to progress further forward to save it. I guess it has been a boat launching machine and has had a lot of salt water on it, either way I wasn't game to touch any of the rust blisters as I know what would have happened next.
