Each month Dr Jeep (Tony Whitehead) takes us through the trials and tribulations at his "Jeep Hospital", USA 4X4 Jeep Specialist in Melbourne, Victoria. Over 20 Jeeps are admitted weekly for servicing and suspension work through to differential, transmission and engine rebuilds. Dr Jeep explains the diagnosis, the corrective surgery and future care of these vehicles.

# Jeep + Hospital

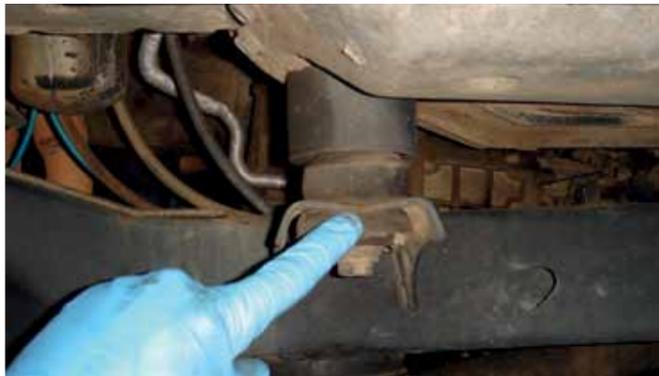
## TJ FRONT BODY MOUNT

The front of the TJ body sits on this body mount each side just under the front foot well and this example has a two inch body lift spacer installed. Keep an eye on these chassis mounts, they tend to bow like this one until they crack through. This will give you an annoying constant squeak as well as not support the tub properly. We take the mount out and make up a custom plate to reinforce the mount and weld it back in, then refit the rubber and bolt it all back together.

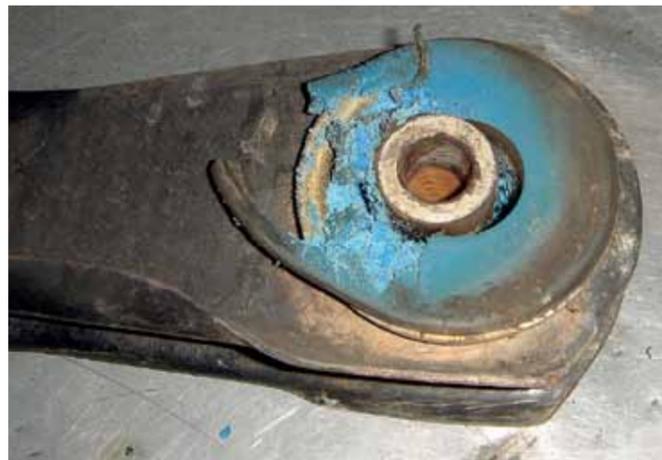
## NYLON BUSHES

This was the front lower arm in a 2002 TJ. They are the same arm in all XJs, ZJs and TJs and had been refitted with a brand X blue nylon bush kit. As you can see this one is worn. I never use these unless it's the last thing I can get. Rubber bushes are so much better for less vibration transmission and longevity. Don't let any one talk you into these.

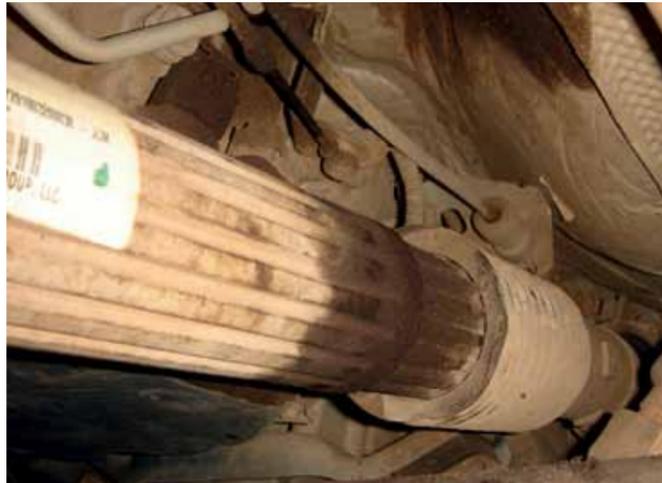
## JK DRIVE SHAFT BOOT

We are seeing a lot of these lately. Front and back JK Wrangler drive shaft boots coming adrift one way or another. This allows mud and crud into the slipping tubes and wrecks your drive shaft. If you see your drive shaft boot not in its correct location, replace or repair it as soon as possible.

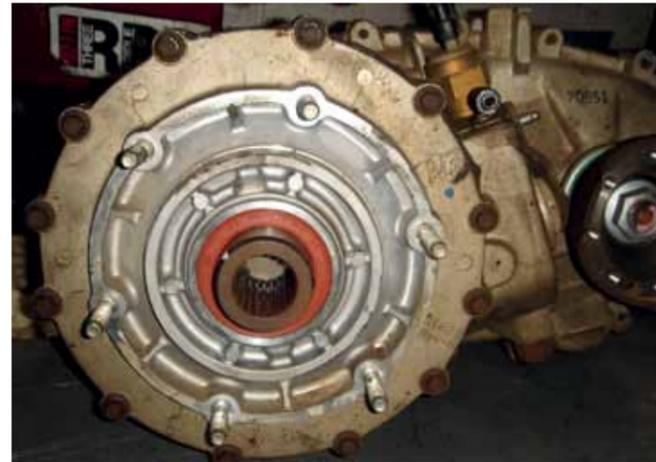
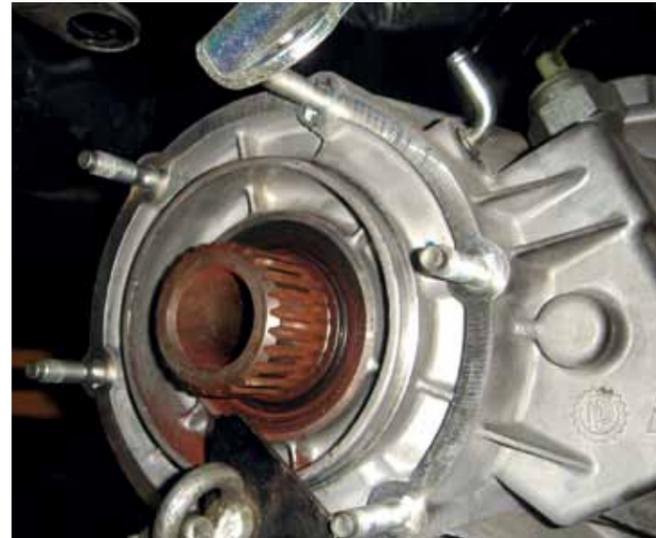
## 5 SPEED AUTO OUTLET

One of my plans hit a hiccup recently. We planned on swapping in a NV241R Rubicon transfer case with the 4:1 low range to the 2012 JK auto with the Pentastar. After pulling the standard 2.72:1 NV241 we discovered the new auto has a different output shaft, like a WG, the input shaft of the rocktrac was too small and we refitted it up and will see what we can do later to make it match. Watch this space.

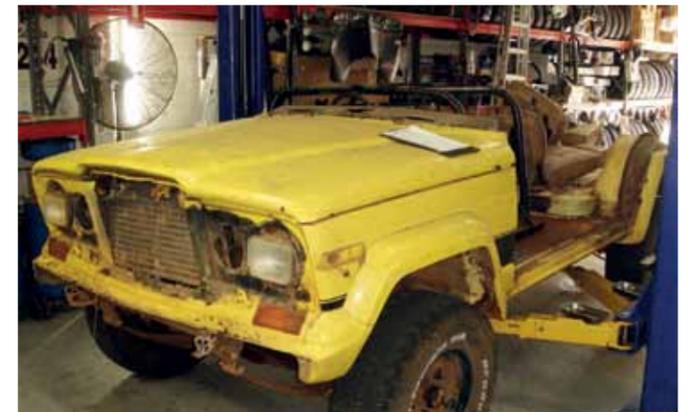
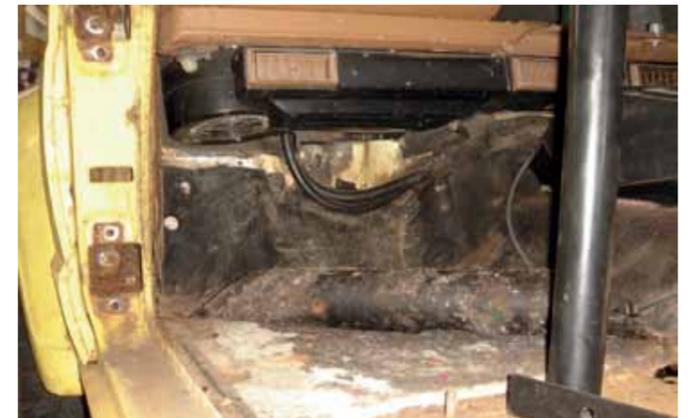
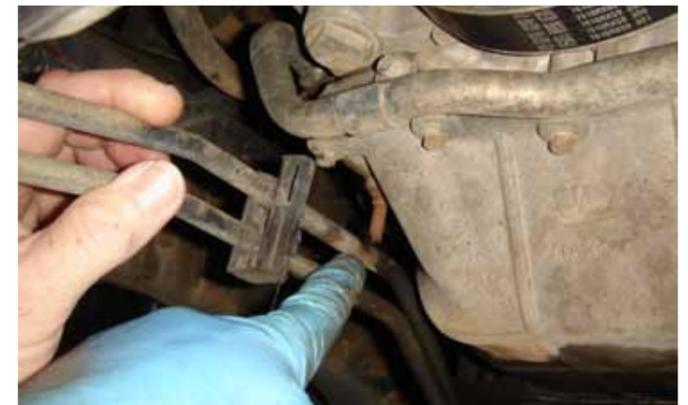
## ASBESTOS JEEP

We're building up an old SJ Chief. It was so rusted that the body was removed and in that process we were taking the old rubber floor mats out and found this. Factory asbestos floor molded mats. They would have been installed in Toledo in 1977. If you have an old SJ or J Truck bear in mind you might have these mats too and drilling into them is a bad thing. We had to have them removed and disposed of properly before any more work. I guess they worked well and I learned a good way to ID asbestos in the process. Place a little on the end of a pocket knife and light it with a flame, if it burns it's AC sheet. If it doesn't burn and glows it's asbestos, so be careful and dispose of it properly.
