Each month Dr Jeep (Tony Whitehead) takes us through the trials and tribulations at his "Jeep Hospital", USA 4X4 Jeep Specialist in Melbourne, Victoria. Over 20 Jeeps are admitted weekly for servicing and suspension work through to differential, transmission and engine rebuilds. Dr Jeep explains the diagnosis, the corrective surgery and future care of these vehicles.

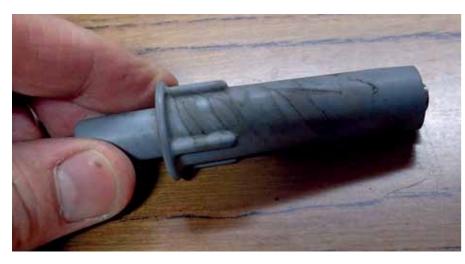
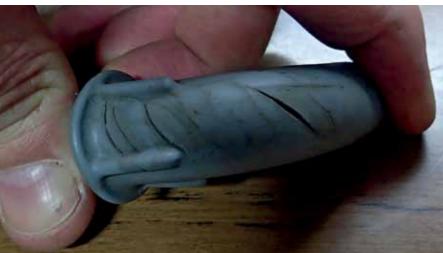
JK 3.8L

This 3.8L V6 |K had a set of spark plugs replaced as part of the regular service here. What we didn't notice was one of the leads had degraded to some extent and in changing the spark plugs we had stirred the hornets nest. As it was not evident until doing a 100 kph test run (we don't do here as its too far to drive to get to the freeway). At that speed under load the motor was down on power. After the customer brought it back I scanned the PCM for faults. We found #6 plug fault code came up and then found this crusty spark plug lead cap. It looked fine until you bent it, so we replaced the leads and cleared the codes, then a 100 kph test run proved successful.
